Current Procedures for Assessment of BDR in Helicopters

Aviation Engineering Directorate (AED) Maintenance Engineering Division (MED)

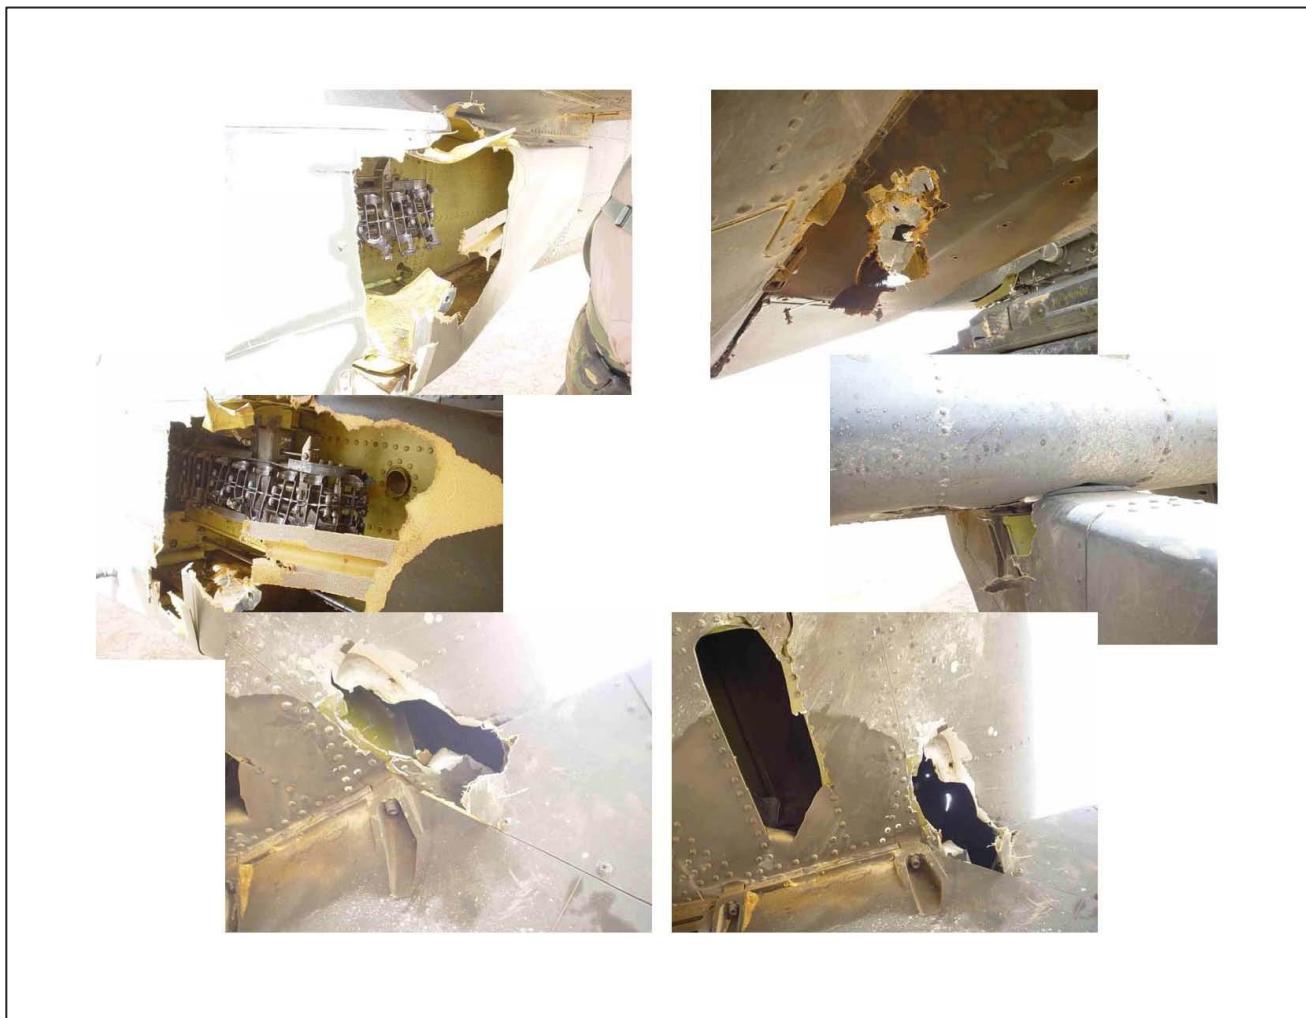
Figure 2: Apache Battle Damage Example

Damage: Rocket Propelled Grenade (RPG) punctured left panel L175 at FS 178, Water Line (WL) 126 causing a hole. Round impacted the 30mm spike accumulator at FS 179 WL 129 destroying the mounts and dislodging the accumulator. The accumulator hit the frame assembly at FS 182 causing a 3" X 1.5" hole in the frame assembly. The RPG round and accumulator continued out the left L194 panel causing a hole in the panel of 4" X 6". Both parts hit the left hand wing between the #2 and #3 wing ribs at Left Butt Line (LBL) 41. Damage to wing unknown.

Repair: Hole in bottom of panel L175 was not repaired. Mounts for 30mm spike accumulator repaired by AVIM sheet metal. Spike accumulator was replaced along with the hydraulic lines that were damaged. Frame assembly at FS 182 was repaired using .040" T3 AL doubler, panel L194 replaced and the left wing was replaced.

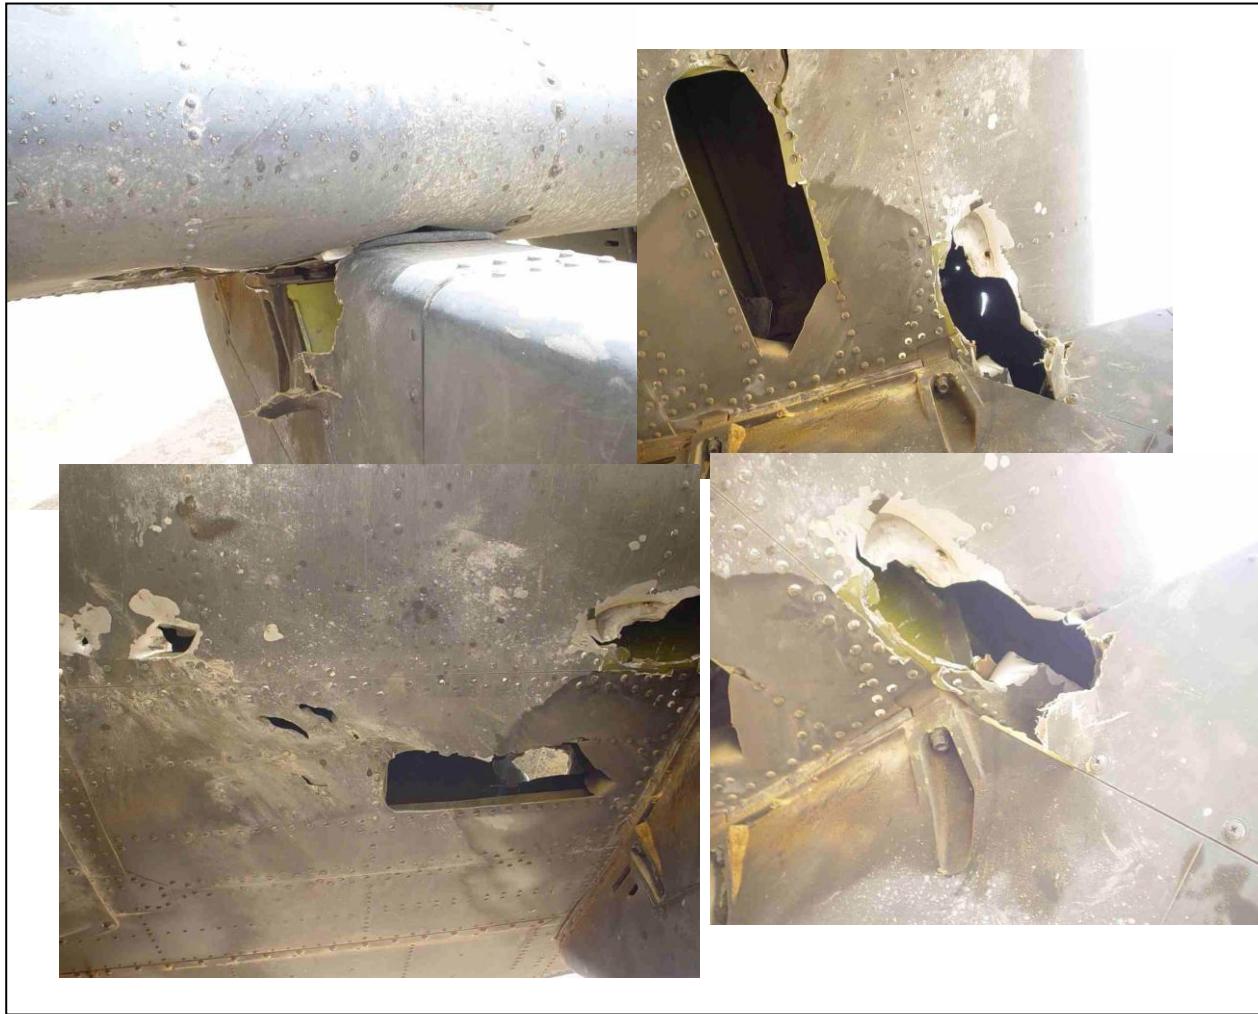
Figure 3: Apache Battle Damage Example, Close Up

Damage: Small arms bullet punctured the outer skin on the underside of the Right Hand (RH) engine nacelle at FS 254, WL 164, Right BL (RBL) 30 putting a 0.3" X 0.3" hole in the skin. Bullet continued on through the APU oil sump and lodged itself inside the APU.

Damage: Bullet entered B60 panel at FS 70, WL 104, LBL 4 causing a 0.3" X 0.3" hole in panel, continuing on and severed 5 wires in wiring harness W211 and destroyed the hard mount for the Co-Pilot Gunner's lateral LVDT.

Repair: The APU was replaced. The hole in the skin has not been patched.

Repair: Hole in B60 panel not repaired. Wiring harness repaired by ARMT. Mount for LVDT replaced with .040" T3 AL, and LVDT was replaced.

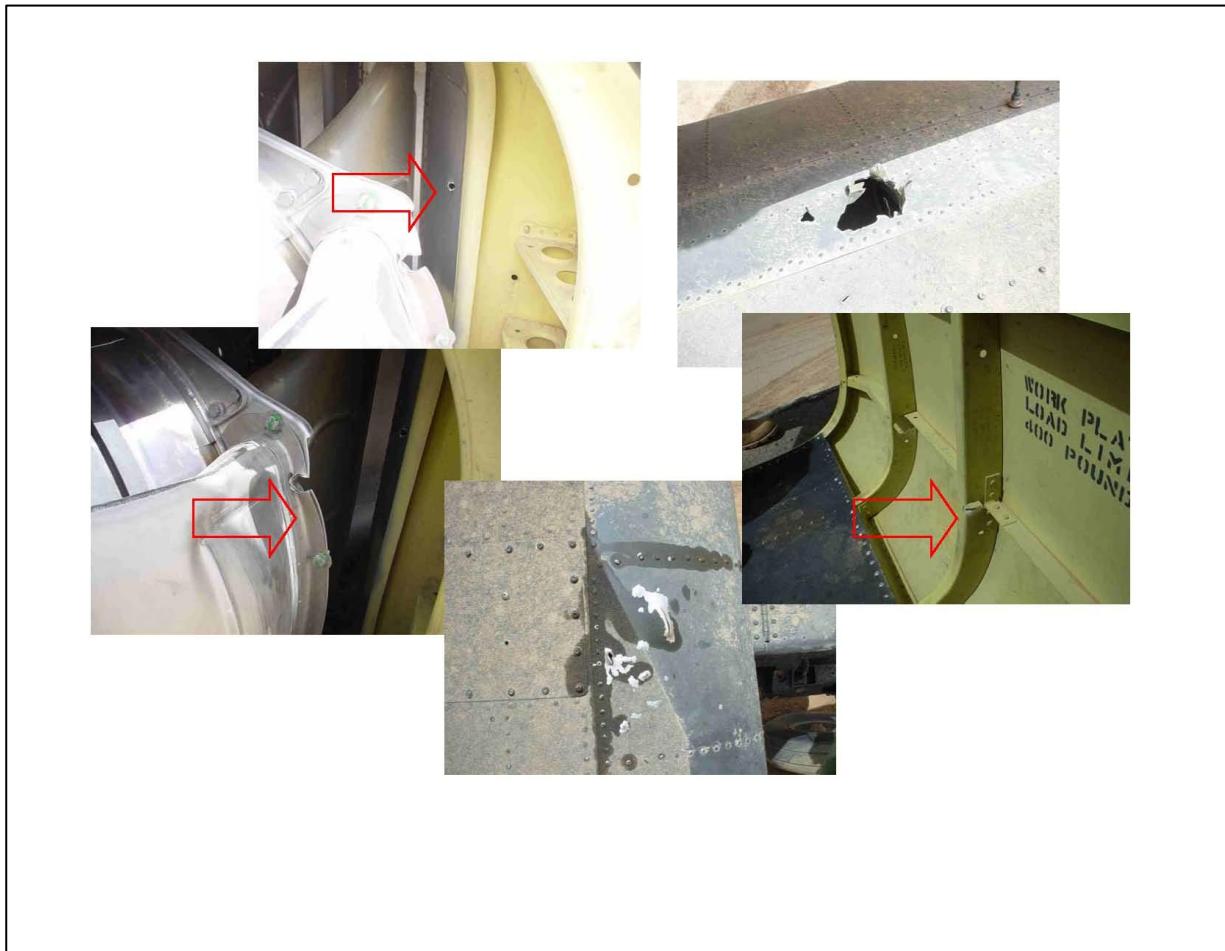
Figure 4: Apache Battle Damage Example Two

Damage: Small arms round entered left side exhaust fairing at the center of outboard side. Round continued through nacelle canted frame at FS 284.5, LBL 40.25. This hole was approx. 0.35" x 0.35". Bullet then hit upper outboard nacelle longeron at FS 282.1, LBL 40.5. This hole was approx. 0.5" x 0.7". Round continued and entered nacelle work platform at FS 251.5, LBL 38, creating a 1.7" x 1.1" hole. Round exited nacelle door at FS 264.5 - 260.5, LBL 36, making a 3" x 1" hole.

Damage: Small arms round entered wing 3 inches aft of the number 1 wing stinger at approx LBL 70, creating a 0.35" x 0.7" oblong hole. Round fragmented leaving 3 dents on leading edge approx 1.5", 2.65", & 3.85" forward of the forward spar. All these dents were located between aft rib LBL 78 and forward rib LBL 66. The round exited through the skin 4.6" forward of the forward wing spar, between the same ribs as dents.

Repair: Exhaust fairing was patched and filled. Damage to nacelle canted frame and longeron was filled, cleaned and deferred. Nacelle platform was repaired using a 2½" x 2½" inch patch of .032" T3 AL. Nacelle door was also patched with 4" x 2" .032" T3 AL patch.

Repair: Extent of internal wing damage yet to be determined. Entrance hole in wing was patched with a 3" x 3" .032" T3 AL patch and the exit hole was filled and patched with 4" x 3" .032" T3 AL patch.

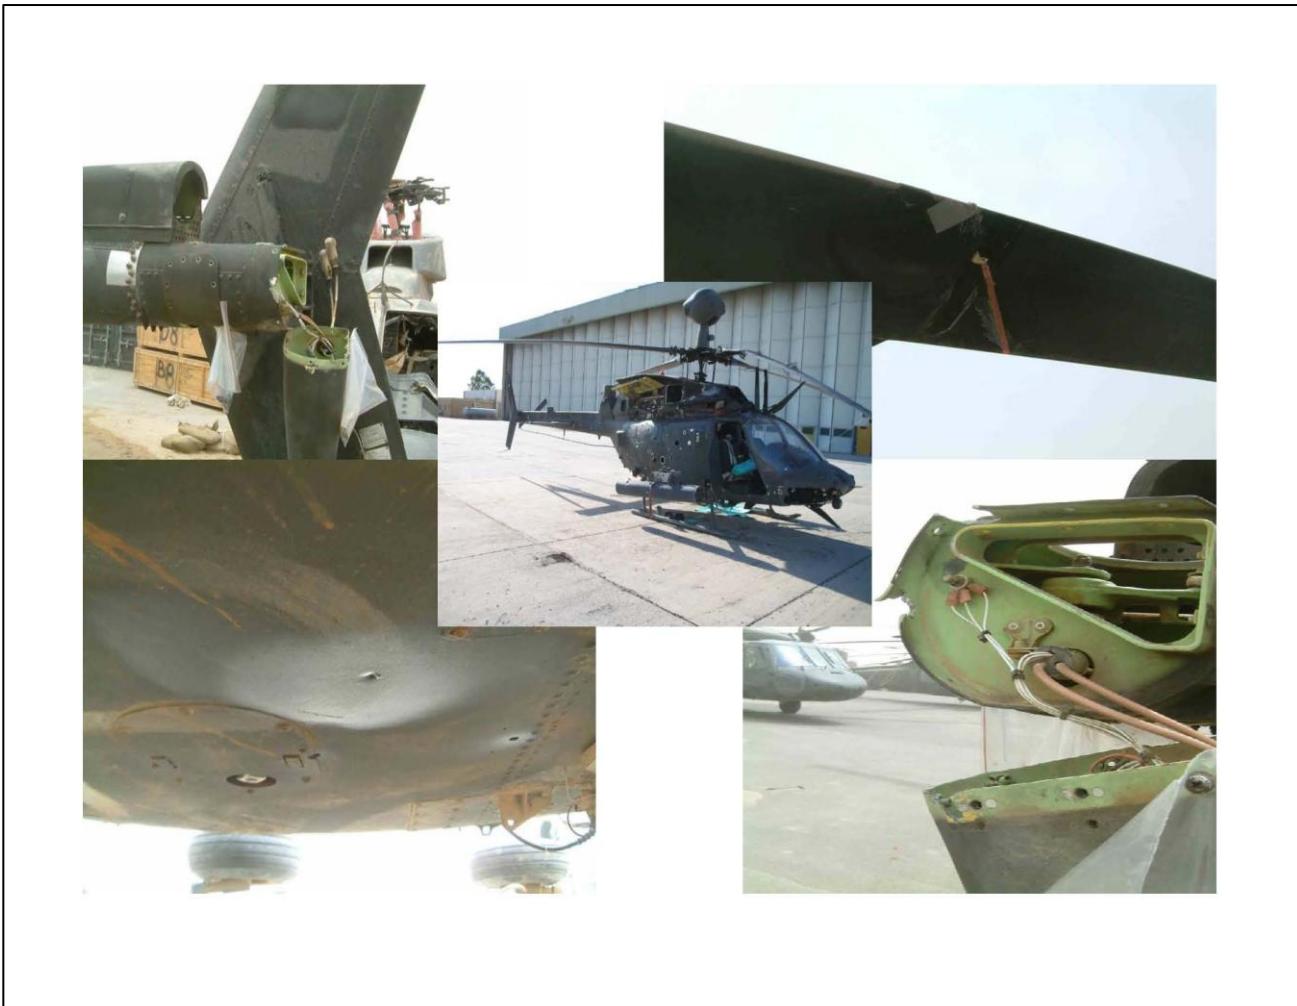
Figure 5: OH-58D Kiowa Battle Damage Example

Damage: Small arms fire resulted in one hole through a blade. Minor damage on the top side (not pictured). Another hole thru the belly and fuel cell with slight leakage and one hole through the Tail Rotor Gear Box fitting. The aircraft was able to return to base with some vibration.

Repair: Repair of this aircraft consisted of tailboom that came from another crash damaged aircraft (cannibalization/controlled exchange). All holes were patched in accordance with standard repair practices at the AVIM level.

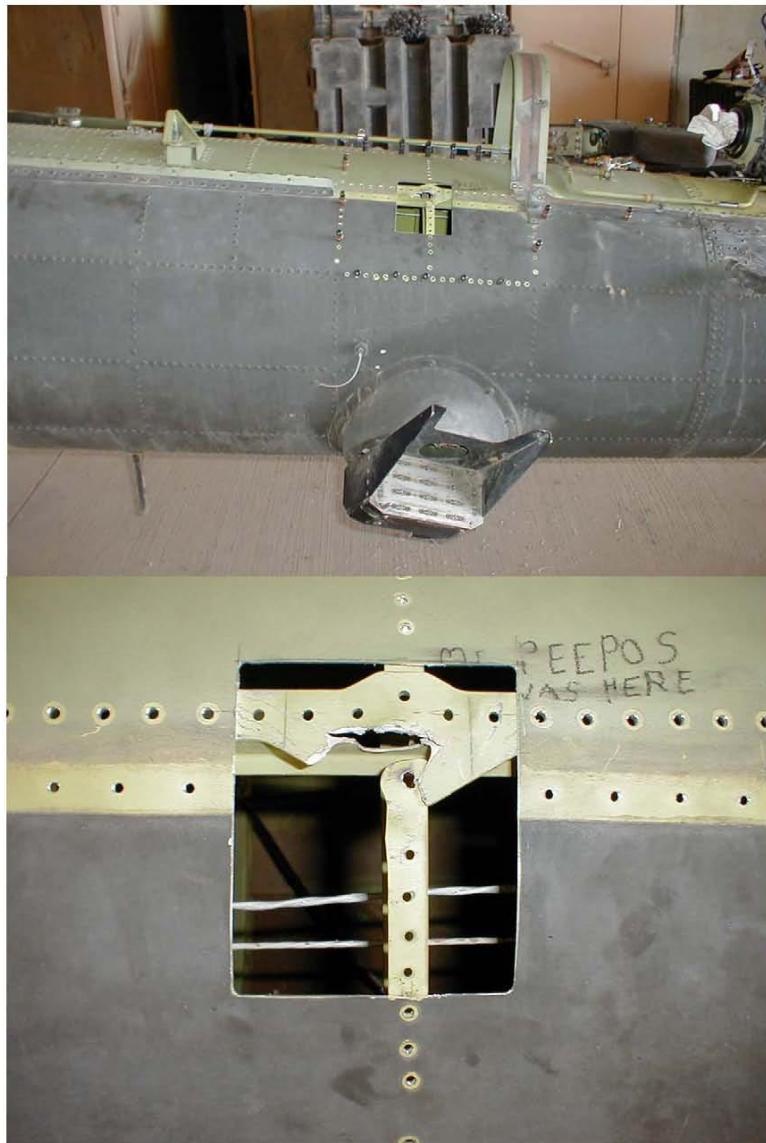
Damage: This aircraft was flown approximately 30 hours in this condition. During phase maintenance inspection (PMI), it was discovered that the aircraft had in fact, suffered battle damage to the tailboom at frame 496.0, sectional zone location, 2L stringer as seen in Figure 6. The bullet entered through the right side of the tailboom, exiting on the left side impacting the 2L stringer. Other than skin damage there was no other structural damage to the right side of the tailboom. After initial damage assessment, the area was "cleaned up", as shown in Figure 7, to facilitate evaluation of best repair procedure. The on-site Boeing Contractor Field Service Representative (CFSR) developed a repair procedure that was implemented.

Figure 6: AH-64D Apache Tailboom Battle Damage

Figure 7: AH-64D Apache Tailboom Battle Damage, Cleaned Up

Repair: The repair was a standard, TM 1-1500-204-23 (series) type repair using standard sheet metal practices. The damaged section of the frame flange was removed but NOT the web, only the top flange. See crosshatch on left and black colored section in Figure 8. An L Angle was fabricated from .040: 7075T6 AL, and riveted in picking up 3 fasteners in undamaged portion of frame. Spacer was fabricated from 7075T6 AL as required for proper shim and fitment.
